**Flood Control Project Maintenance
Levee Inspections**
LMA District Cover Sheet
Spring 2018 Levee Inspection Results

Sutter Maintenance Yard East Levee Sutter Bypass

Spring 2018 Levee Inspection Results

Waterway			Bank	Unit Miles
Unit No. 01 Sutter Bypass Levee			Left	21.68
	Spring (March - May)	Summer (June - August)	(September - November) Fall	Winter (December - February)
Unit Maintenance Rating (Fall Only)				
Date of Inspection	3/27/2018 - 3/27/2018			
DWR Inspector	Bob Duffey			
Accompanied By	Steve Beckley Sutter Maintenance Yard

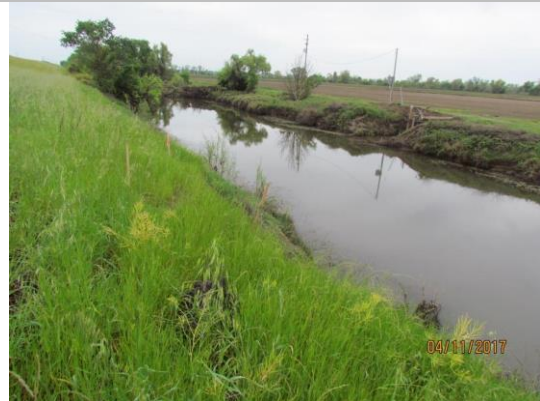
Photo 1 of 1 : SP_2018_ST0002_450_42_20180305_00012.jpg

LM Start	0.36	Rating **	M	Issue No.	42
LM End	0.36	Issue Type +	Ma	Location *	WS
Category	Earthen Levee			GPS Latitude/Longitude	
				Start	End
Item	Erosion / Bank Caving			39.147183 °	39.147183 °
				-121.828142 °	-121.828142 °
DWR ID	DWR_ST0002_01_s_2017_42				
Comment Code					
E1 : Note and monitor erosion site.					
Inspector Comment					
Repair the erosion along the water side toe.

View of the erosion along the waterside toe.

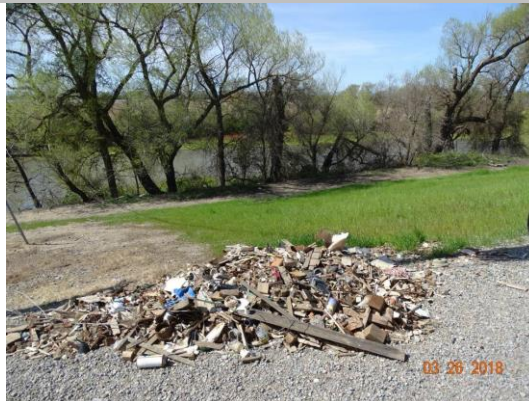
Photo 1 of 1 : SP_2018_ST0002_450_46_20180403_00078.jpg

View of the garbage along the waterside slope.

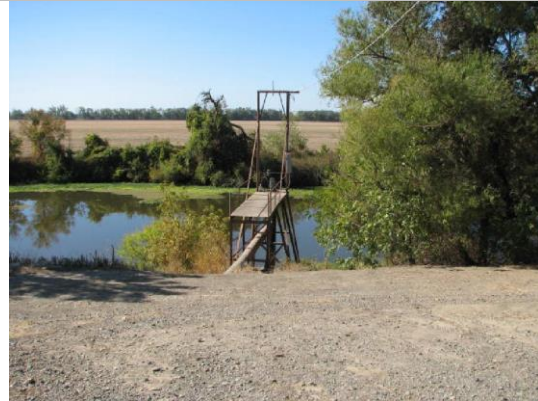
Photo 1 of 3 : UCIP_SP_2018_51560_64805.jpg

FS_ID:51560
DS_ID:16862
EP_NO: 10932
Repair Type: Non-Urgent
Crossing Status: Found
UCIP Comments: 4/11/2017 Riser knocked out of place on WS shoulder and no sign of the siphon breaker. Suspect it was buried. (DWR Sutter Yard- A Freitag) 10/10/2016 WS CMP riser is still knocked out of place and siphon breaker is suspected to be buried. (DWR Sutter Yard - a Freitag) 4/18/2016 CMP riser is still knocked out of place and a siphon breaker cannot be found. 5/7/2015 24in. cmp riser and siphon breaker were not found on the WS shoulder. 11/12/2014 Same as last inspection. 5/13/2014 Same as last inspection. 10/30/2013 24in. cmp riser was pulled out of levee and there is no sign of a siphon breaker on WS shoulder. 5/22/2013 24in. cmp riser on WS shoulder is full of garbage and dirt and should be cleaned out to inspect siphon breaker. 10/8/2012 Pier has no walkway to access pump on pier. This is not necessarily an issue. FIELD_STRUCT_DESC: 16-inch coated steel irrigation pipe through the levee, 6.3 feet below the crown. Vertical pump mounted on a steel structure on the bank. Siphon breaker in a 24-inch corrugated metal pipe riser on the waterside (WS) slope. Concrete distribution box on the landside (LS). Power and communication joint pole (JP) on the WS shoulder. Original equipment in O&M. Hand drawings available in permit. (Original O&M entry removed in 1975 and replaced under Permit No. 10932, 1976 - Edward Nall) [Additional Reference(s): DWR Levee Log, 2005. USACE Sacramento O&M Manual 315, May 1953 (Station 1094+80)].

Pump on metal pier on WS slope.

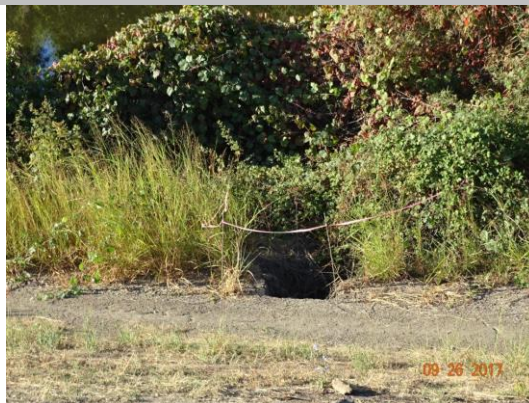
Photo 1 of 1 : SP_2018_ST0002_450_57_20180305_00013.jpg

LM Start	1.53	Rating **	U	Issue No.	57
LM End	1.53	Issue Type +	Ma	Location *	WS
Category	Earthen Levee			GPS Latitude/Longitude	
				Start	End
Item	Erosion / Bank Caving			39.137373 °	39.137373 °
				-121.810382 °	-121.810382 °
DWR ID	DWR_ST0002_01_f_2017_57				
Comment Code					
E2 : Schedule repair of erosion site prior to the next inspection.					
Inspector Comment					
Repair the beaver hole along the waterside berm.

View of the beaver hole along the waterside berm.

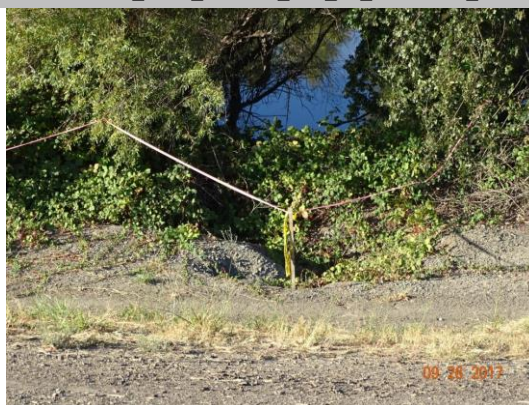
Photo 1 of 1 : SP_2018_ST0002_450_58_20180305_00014.jpg

LM Start	1.57	Rating **	U	Issue No.	58
LM End	1.57	Issue Type +	Ma	Location *	WS
Category	Earthen Levee			GPS Latitude/Longitude	
				Start	End
Item	Erosion / Bank Caving			39.137010 °	39.137010 °
				-121.809673 °	-121.809673 °
DWR ID	DWR_ST0002_01_f_2017_58				
Comment Code					
E2 : Schedule repair of erosion site prior to the next inspection.					
Inspector Comment					
Repair the beaver hole along the waterside berm.

View of the beaver hole along the waterside berm.

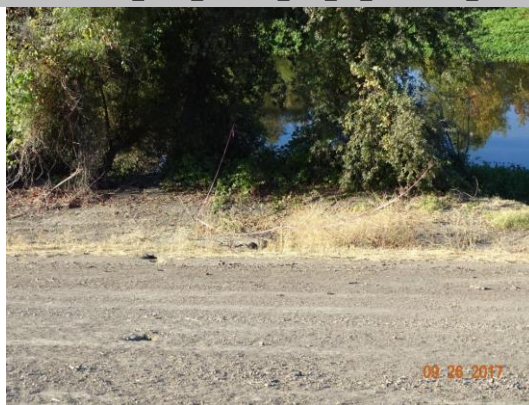
Photo 1 of 1 : SP_2018_ST0002_450_61_20180305_00015.jpg

LM Start	1.61	Rating **	U	Issue No.	61
LM End	1.61	Issue Type +	Ma	Location *	WS
Category	Earthen Levee			GPS Latitude/Longitude	
				Start	End
Item	Erosion / Bank Caving			39.136713 °	39.136713 °
				-121.809202 °	-121.809202 °
DWR ID	DWR_ST0002_01_f_2017_61				
Comment Code					
E2 : Schedule repair of erosion site prior to the next inspection.					
Inspector Comment					
Repair the beaver hole along the waterside berm.

View of the beaver hole along the waterside berm.

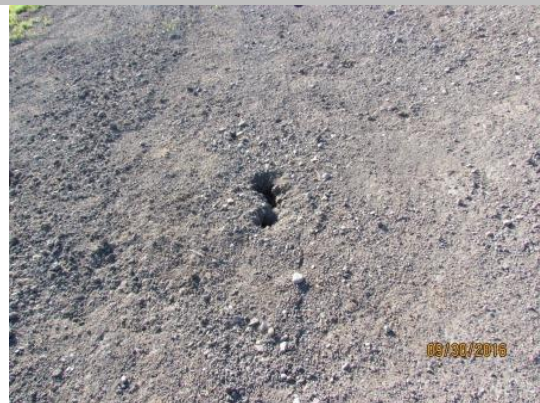
Photo 1 of 1 : SP_2018_ST0002_450_26_20180305_00005.jpg

LM Start	4.81	Rating **	M	Issue No.	26
LM End	4.81	Issue Type +	Ob	Location *	LS
Category	Earthen Levee			GPS Latitude/Longitude	
				Start	End
Item	Cracking			39.108110 °	39.108110 °
				-121.762623 °	-121.762623 °
DWR ID	DWR_ST0002_01_f_2016_26				
Comment Code					
CR1 : Monitor and have inspected by geotechnical engineer.					
Inspector Comment					
Longitudinal cracks caused by fat clay.

View of the longitudinal cracks.

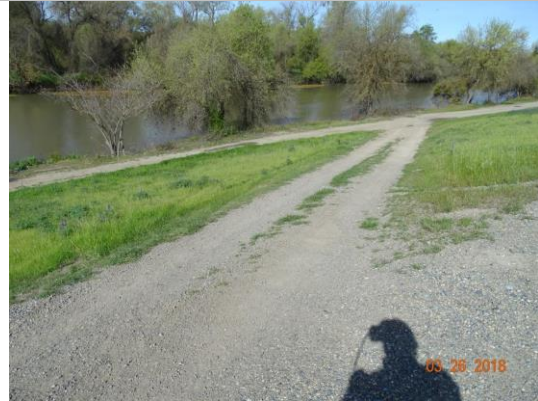
Photo 1 of 1 : SP_2018_ST0002_450_45_20180403_00076.jpg

LM Start	5.19	Rating **	M	Issue No.	45
LM End	5.19	Issue Type +	Ma	Location *	WS
Category	Earthen Levee			GPS Latitude/Longitude	
				Start	End
Item	Slope Stability			39.103368 °	39.103368 °
				-121.758760 °	-121.758760 °
DWR ID	DWR_ST0002_01_s_2018_45				
Comment Code					
Inspector Comment					
Repair the slope damaged by vehicle traffic.

View of the vehicle traffic along the waterside slope.

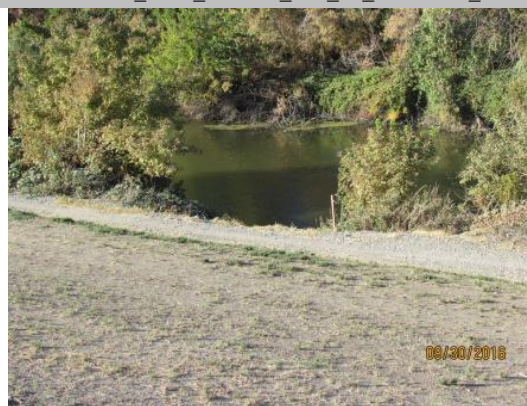
Photo 1 of 1 : SP_2018_ST0002_450_34_20180305_00008.jpg

View of the erosion along the waterside toe.

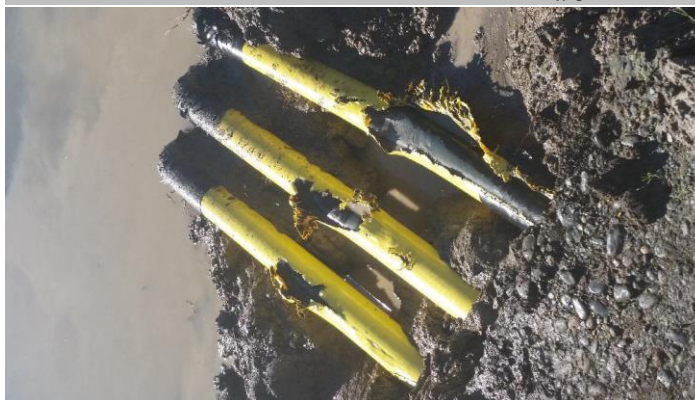
Photo 3 of 3 : UCIP_SP_2018_51620_74958.jpg

FS_ID:51620
DS_ID:16884
EP_NO: 14455
Repair Type: Urgent
Crossing Status: Indicator Found
UCIP Comments: 4/11/2017 The damage to the levee toe was repaired by Sutter Maintenance Yard. The hole was filled in and compacted with rock. The repairs have not yet been made to the gas line by the gas line owners but the damage does not affect the integrity of the levee or bank. Photos updated. (DWR Sutter Yard- A Freitag)10/18/2016 it is unknown if the damage to the levee toe from the farmer getting his tractor stuck has been repaired (DWR UCIP - thatch)
10/10/2016 Crossing appears to be in good condition but im not sure if the damaged pipe section at the WS berm was ever repaired. (DWR Sutter Yard - a Freitag)4/18/2016 Gas line was damaged at the WS berm due to a farmer getting his tractor stuck. Gas company is aware of the damage and will be doing repairs sometime this summer. Damage should not affect the integrity of the levee. (DWR Sutter Yard - a Freitag)5/7/2015 Marker on WS broken. (DWR Sutter Yard - a Freitag)11/12/2014 Same as last inspection. (DWR Sutter Yard - a Freitag)5/13/2014 Same as last inspection. (DWR Sutter Yard - a Freitag)10/30/2013 Same as last inspection. (DWR Sutter Yard - a Freitag)5/22/2013 Carsonite marker on WS shoulder is broken and should be replaced. (DWR Sutter Yard - a Freitag)

Damaged gas lines at the WS berm.

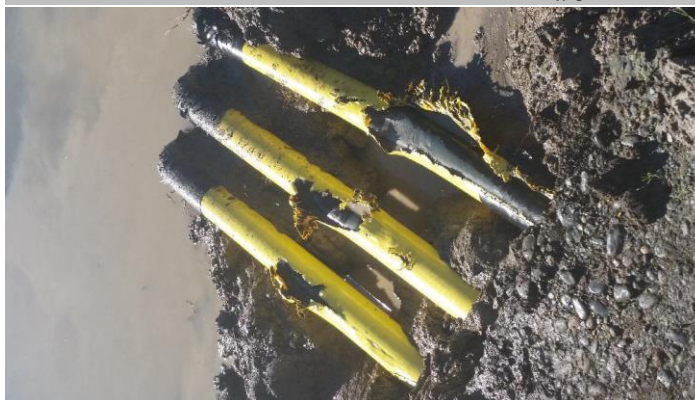
Photo 3 of 3 : UCIP_SP_2018_51622_74960.jpg

Damaged gas lines at WS berm.

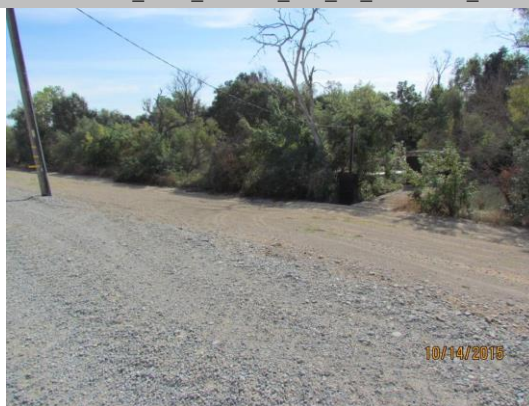
Photo 1 of 1 : SP_2018_ST0002_450_23_20180305_00004.jpg

View of the vehicle erosion along the slope.

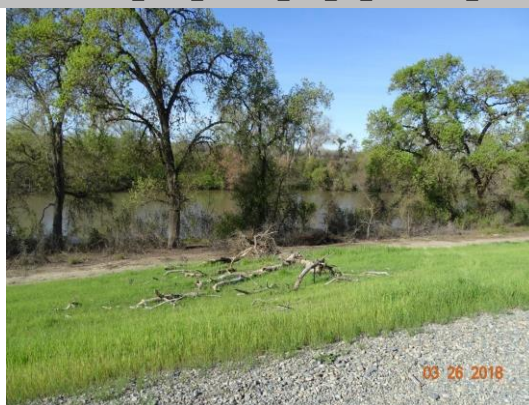
Photo 1 of 1 : SP_2018_ST0002_450_39_20180403_00074.jpg

View of the tree along the waterside slope and toe.

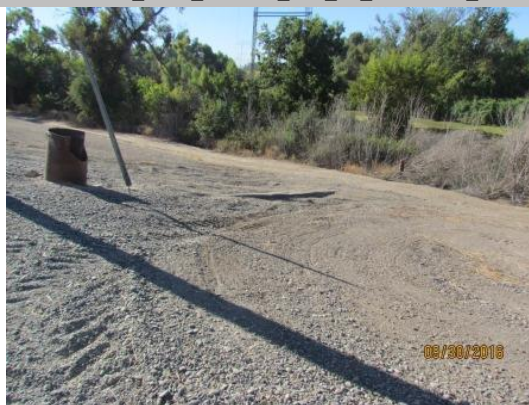
Photo 1 of 1 : SP_2018_ST0002_450_37_20180305_00009.jpg

View of the erosion caused by vehicle traffic.

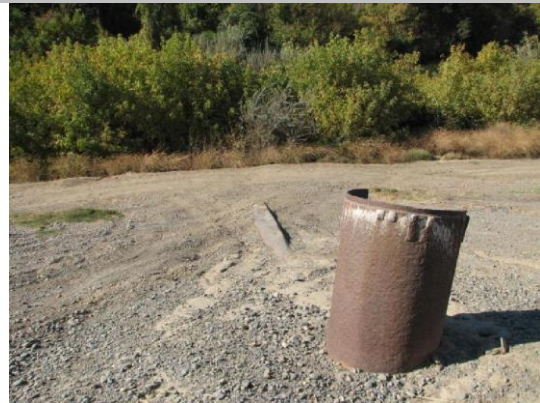
Photo 1 of 3 : UCIP_SP_2018_51605_65314.jpg

Pipe on WS slope exposed and crushed below 30-inch steel riser.

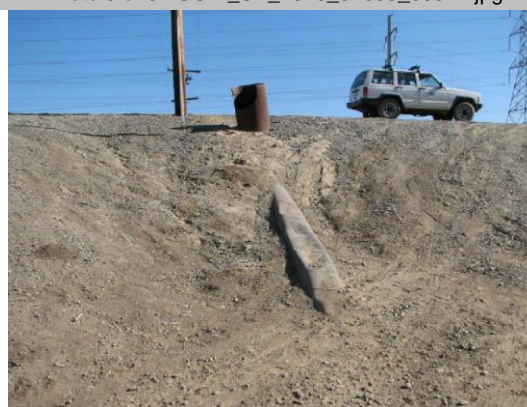
Photo 3 of 3 : UCIP_SP_2018_51605_65312.jpg

Crushed pipe on WS slope.

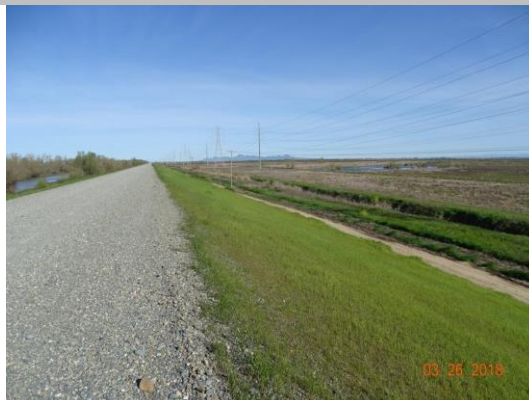
Photo 1 of 1 : SP_2018_ST0002_450_36_20180403_00072.jpg

View of native vegetation on both slopes.

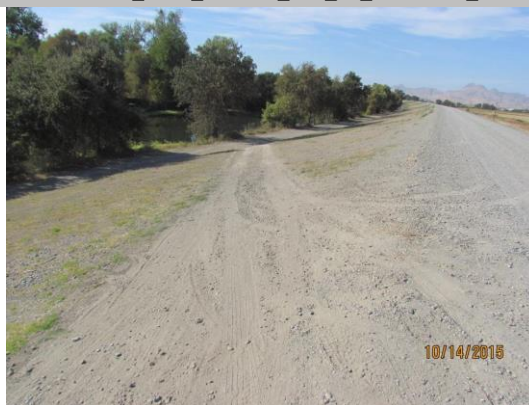
Photo 1 of 1 : SP_2018_ST0002_450_29_20180305_00006.jpg

View of the vehicle erosion along the waterside slope.

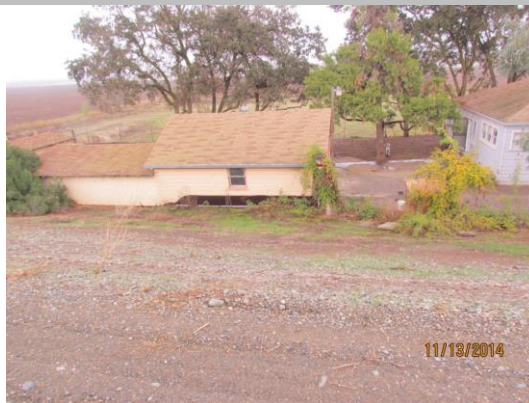
Photo 1 of 1 : SP_2018_ST0002_450_10_20180305_00001.jpg

View of the house next to the toe of the levee.
